SURFACE IRRIGATION EVALUATION  
BOW ISLAND TEST PLOTS

ALBERTA DEPARTMENT OF AGRICULTURE  
WATER RESOURCES DIVISION  
LETHBRIDGE REGION

Prepared by: Glen L. Steed  
Thomas A. Androsoff

Date: June 5th, 1970

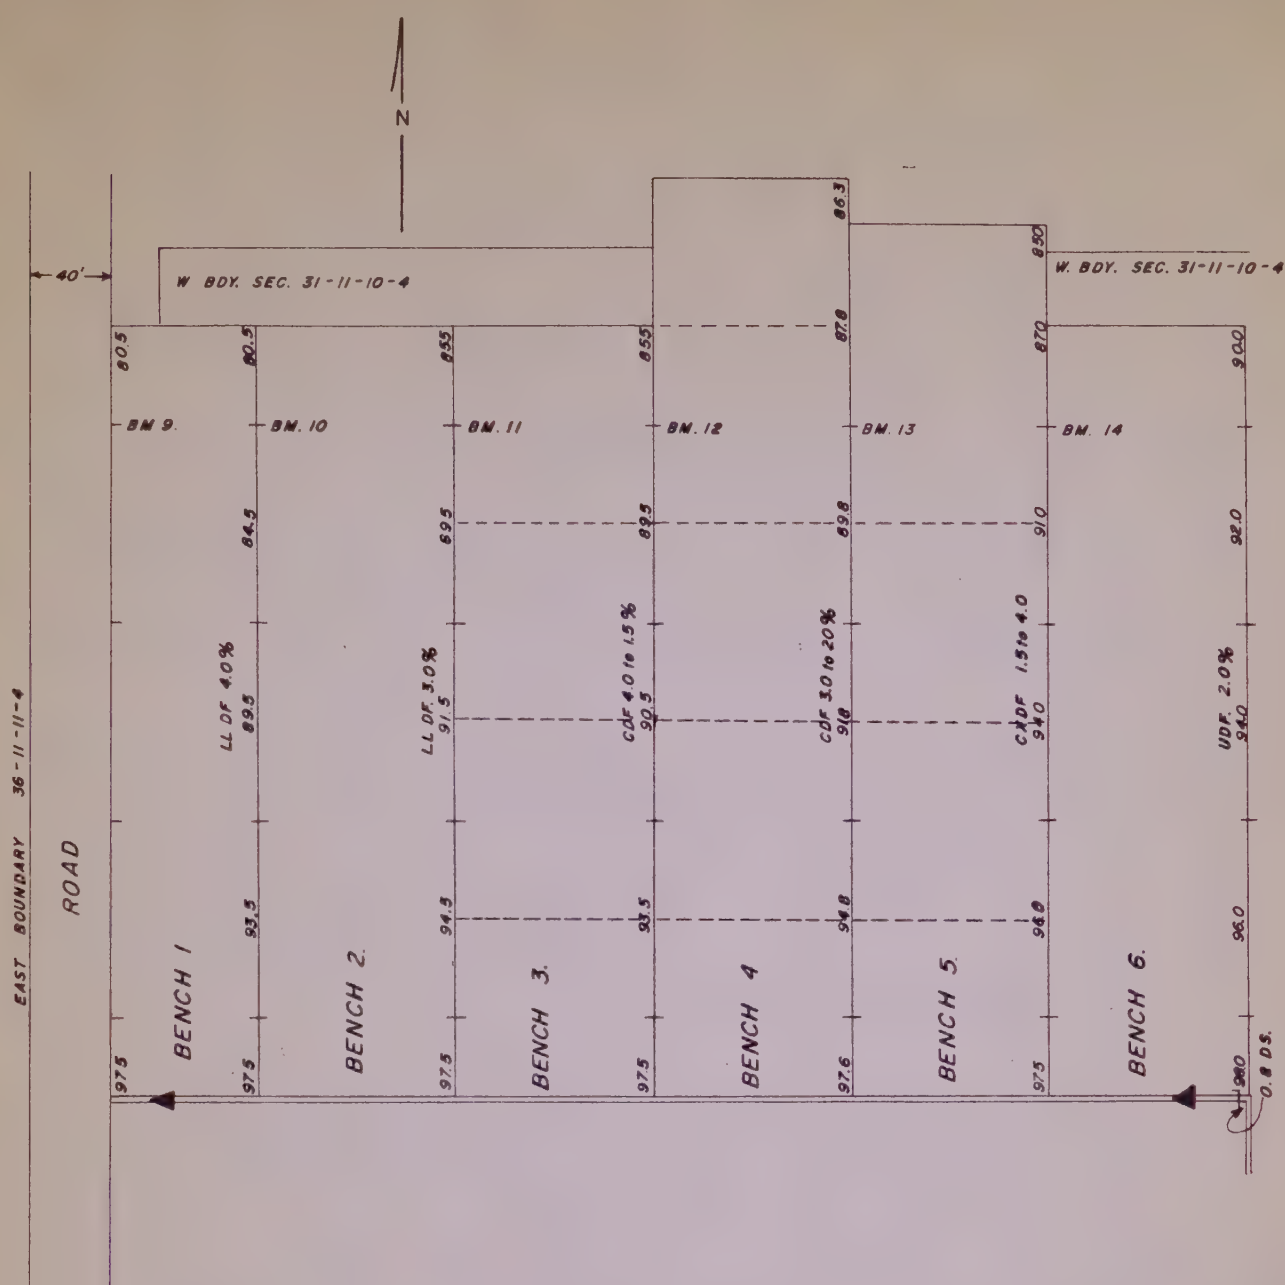
BM - BENCH MARK  
 DF - DOWN FIELDSLOPE  
 UDF - UNIFORM DOWN FIELD  
 CDF - CONCAVE DOWN FIELD  
 CXDF - CONVEX DOWN FIELD  
 DS - DROP STRUCTURE  
 DDS - DROP DIVERSION STRUCTURE

soil moisture blocks and neutron meter access tubes were installed at various sites (see Figure 9). These were installed at the upper and lower ends of major slopes and at one other station between. The location of the instruments in this way was to monitor the effects of slope changes, concave and convex, on the wetting profiles and the profiles on long continuous slopes.

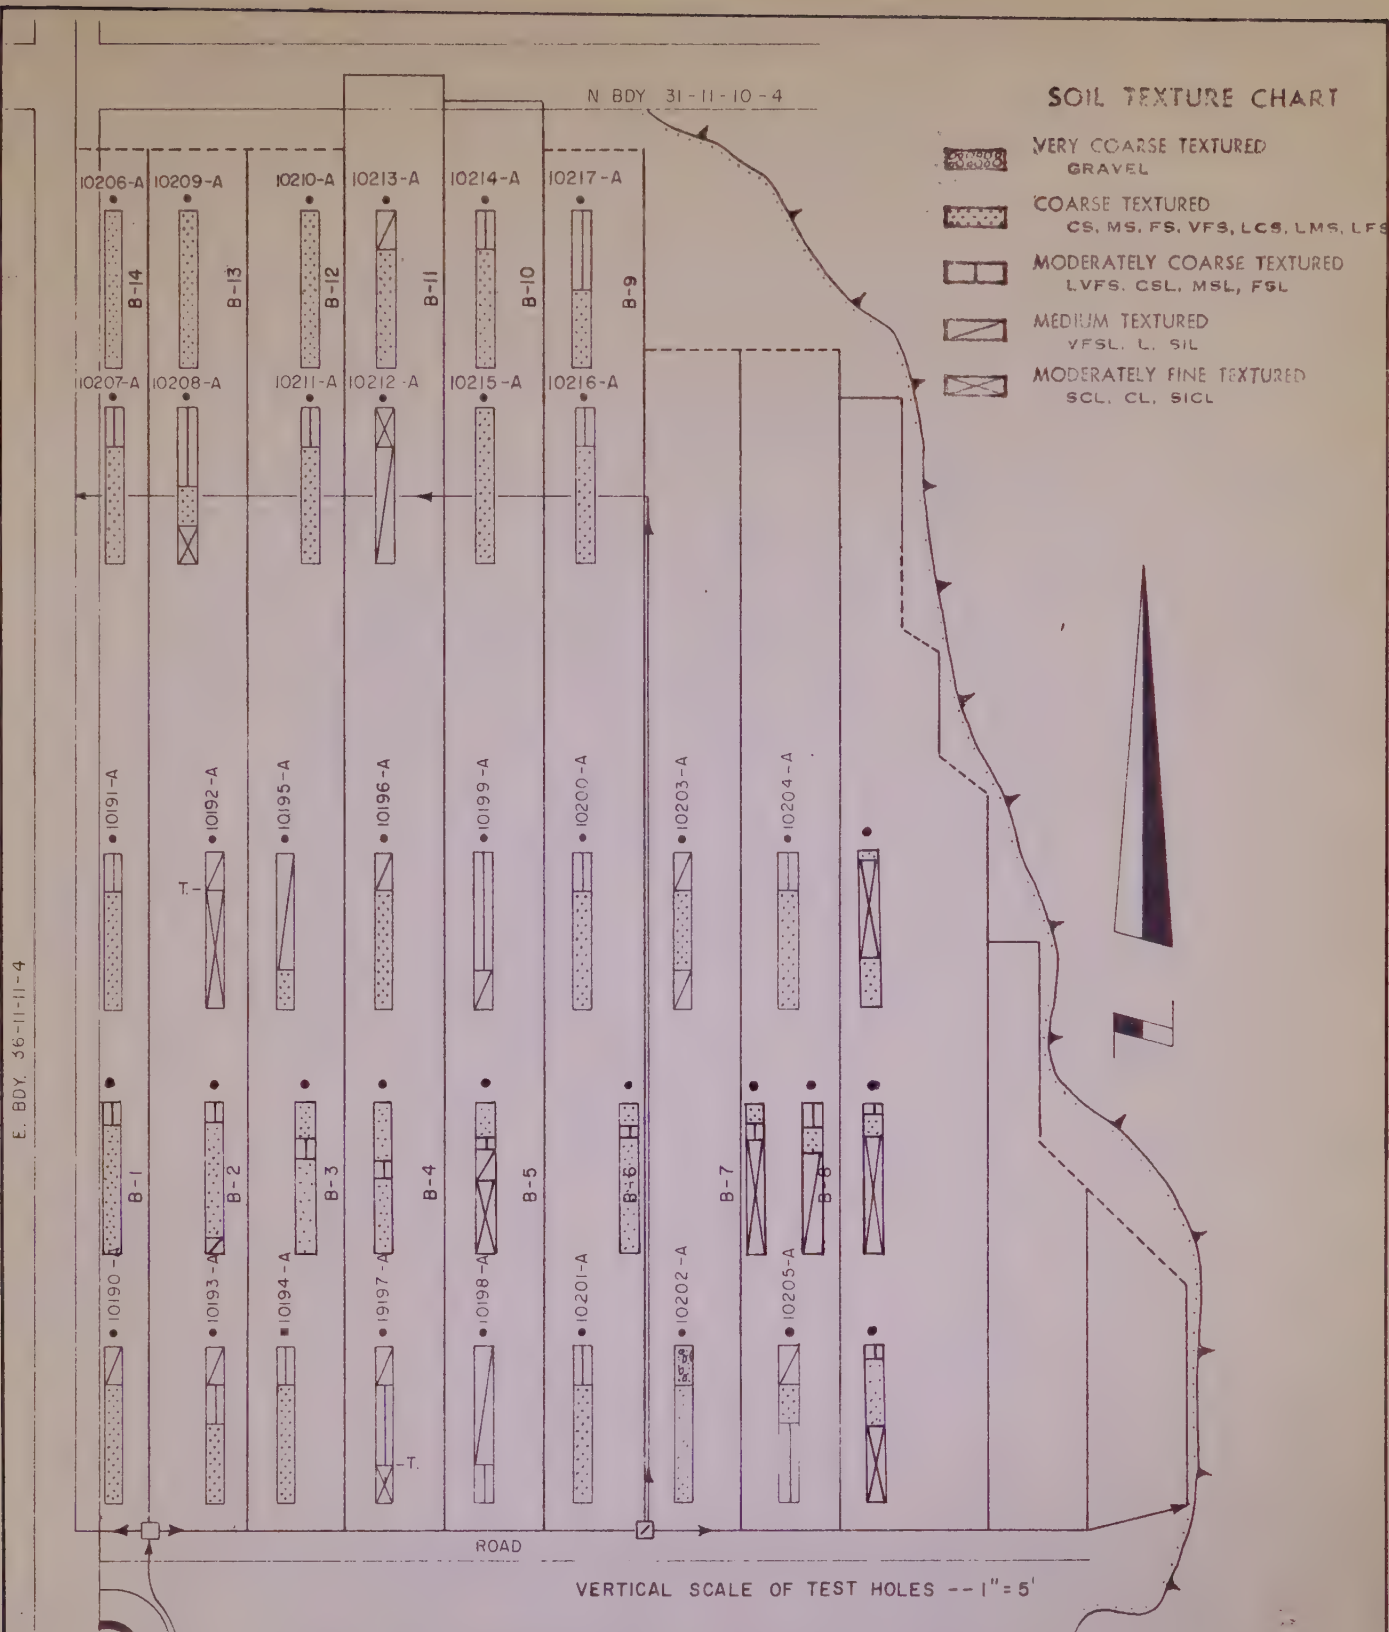
FIGURE 8

<b>BOW ISLAND TEST PLOTS</b> <b>NW-31-11-10-4</b> <b>SOIL LOGS</b>	
Submitted by _____		Designed by _____		Date <b>APRIL 22, 1970</b>	
Date _____		Drawn by <b>T. ANDROSQFF</b>		Sheet _____ of _____	
Approved by <i>Steve B. Stead</i>		Checked by <i>[Signature]</i>		Scale: 1" = 200'	
Date <b>May 28, 1970</b>				File No. <b>C8-M-1-K-28</b>

After levelling, a great variability in the soil profiles resulted (see Figure 8). This is, however, a realistic situation for the study as profile mixing and variations, such as found on the plots, are typical of levelled land in Alberta.

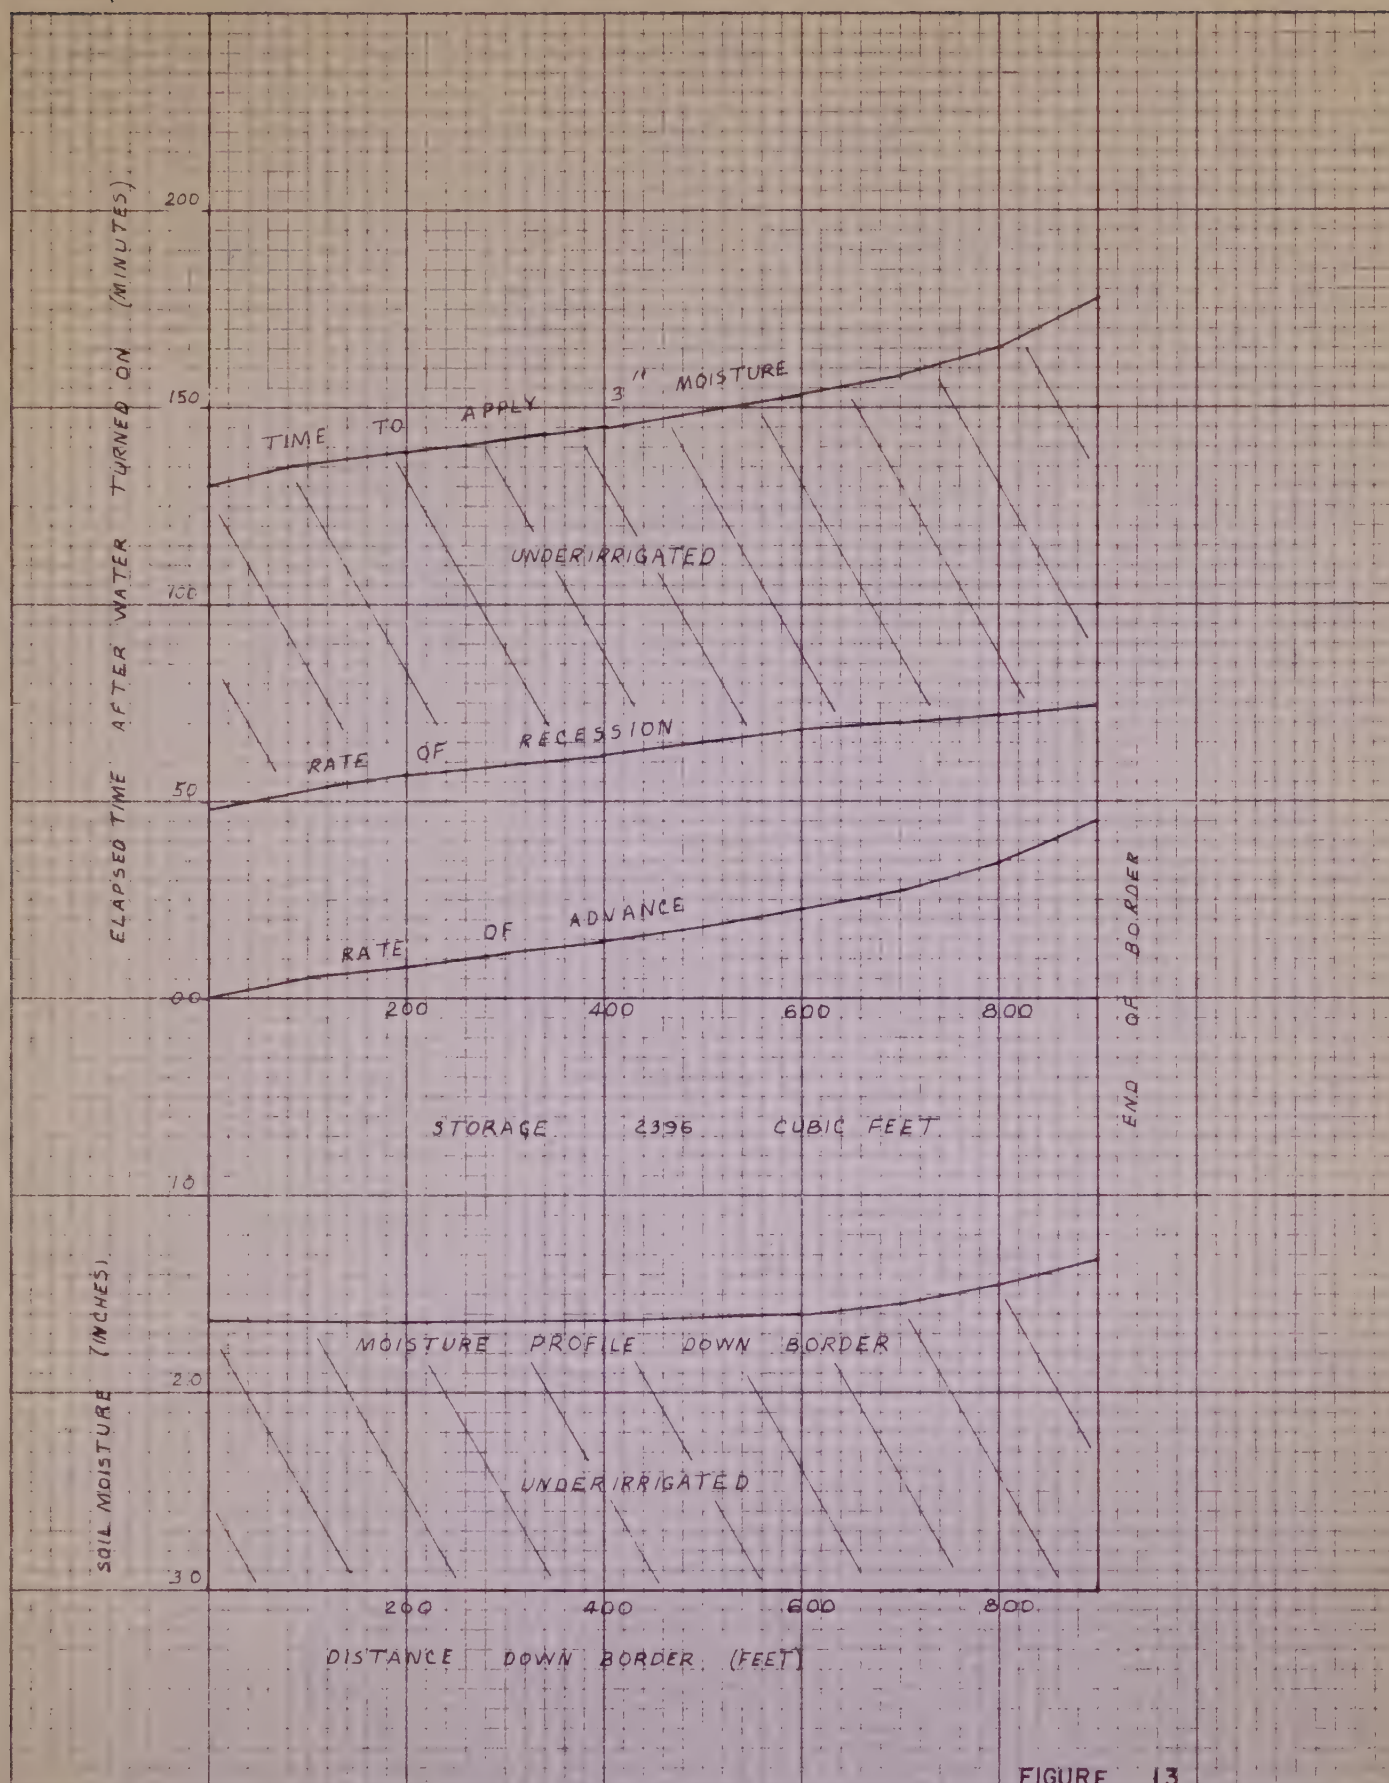
FIGURE 13

BOW ISLAND PLOTS  
 BORDER EVALUATION  
 BENCH 1 BORDER 1  
 JULY 10/69

TIME TO APPLY  
RATE OF RECESSION  
3" MOISTURE  
UNDERIRRIGATED

MOISTURE PROFILE DOWN BORDER  
UNDERIRRIGATED

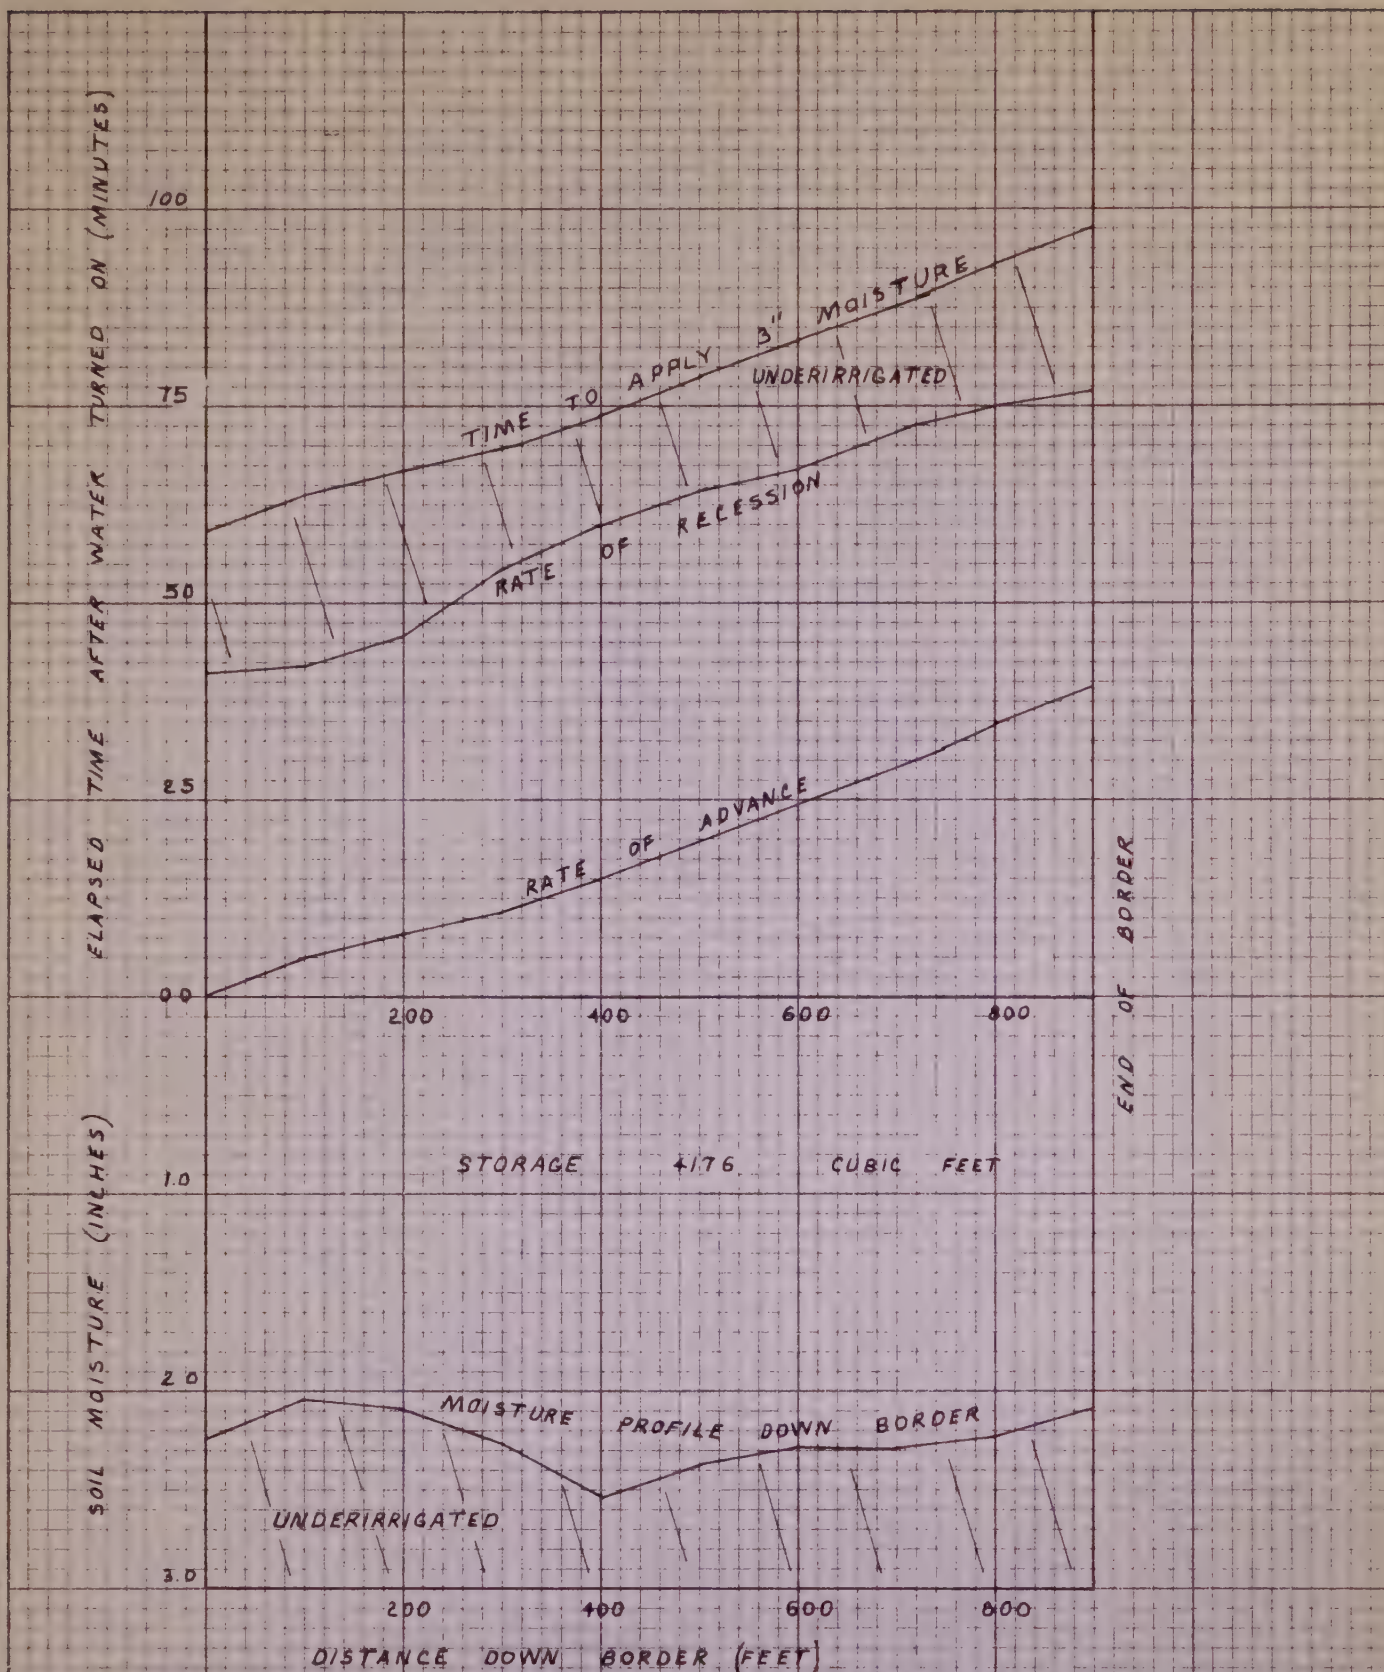
FIGURE 16

BOW ISLAND PLOTS  
 BORDER EVALUATION  
 BENCH 5 BORDER 2  
 JUNE 11/69

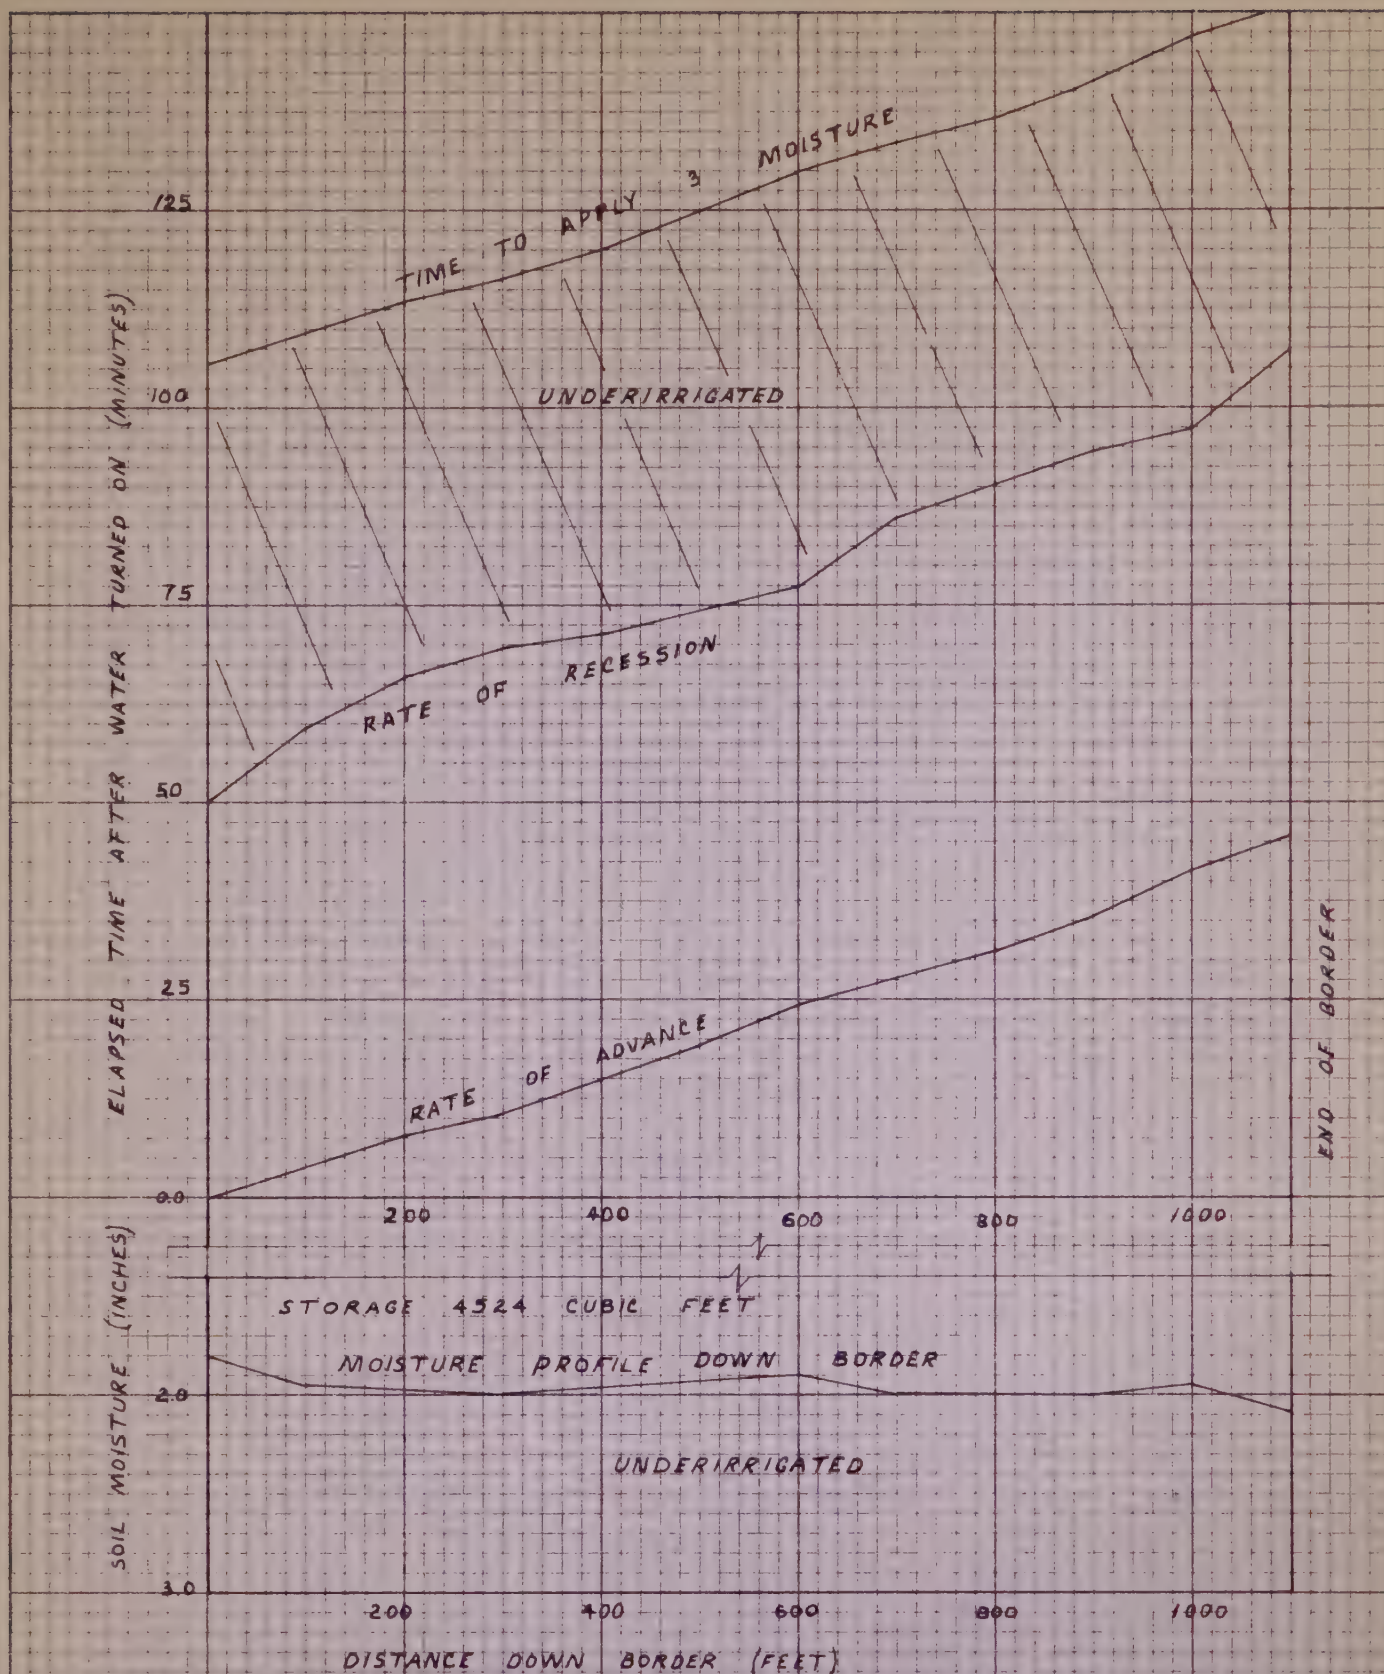
FIGURE 17  
BOW ISLAND PLOTS  
BORDER EVALUATION  
BENCH 7 BORDER 2  
JUNE 12/69

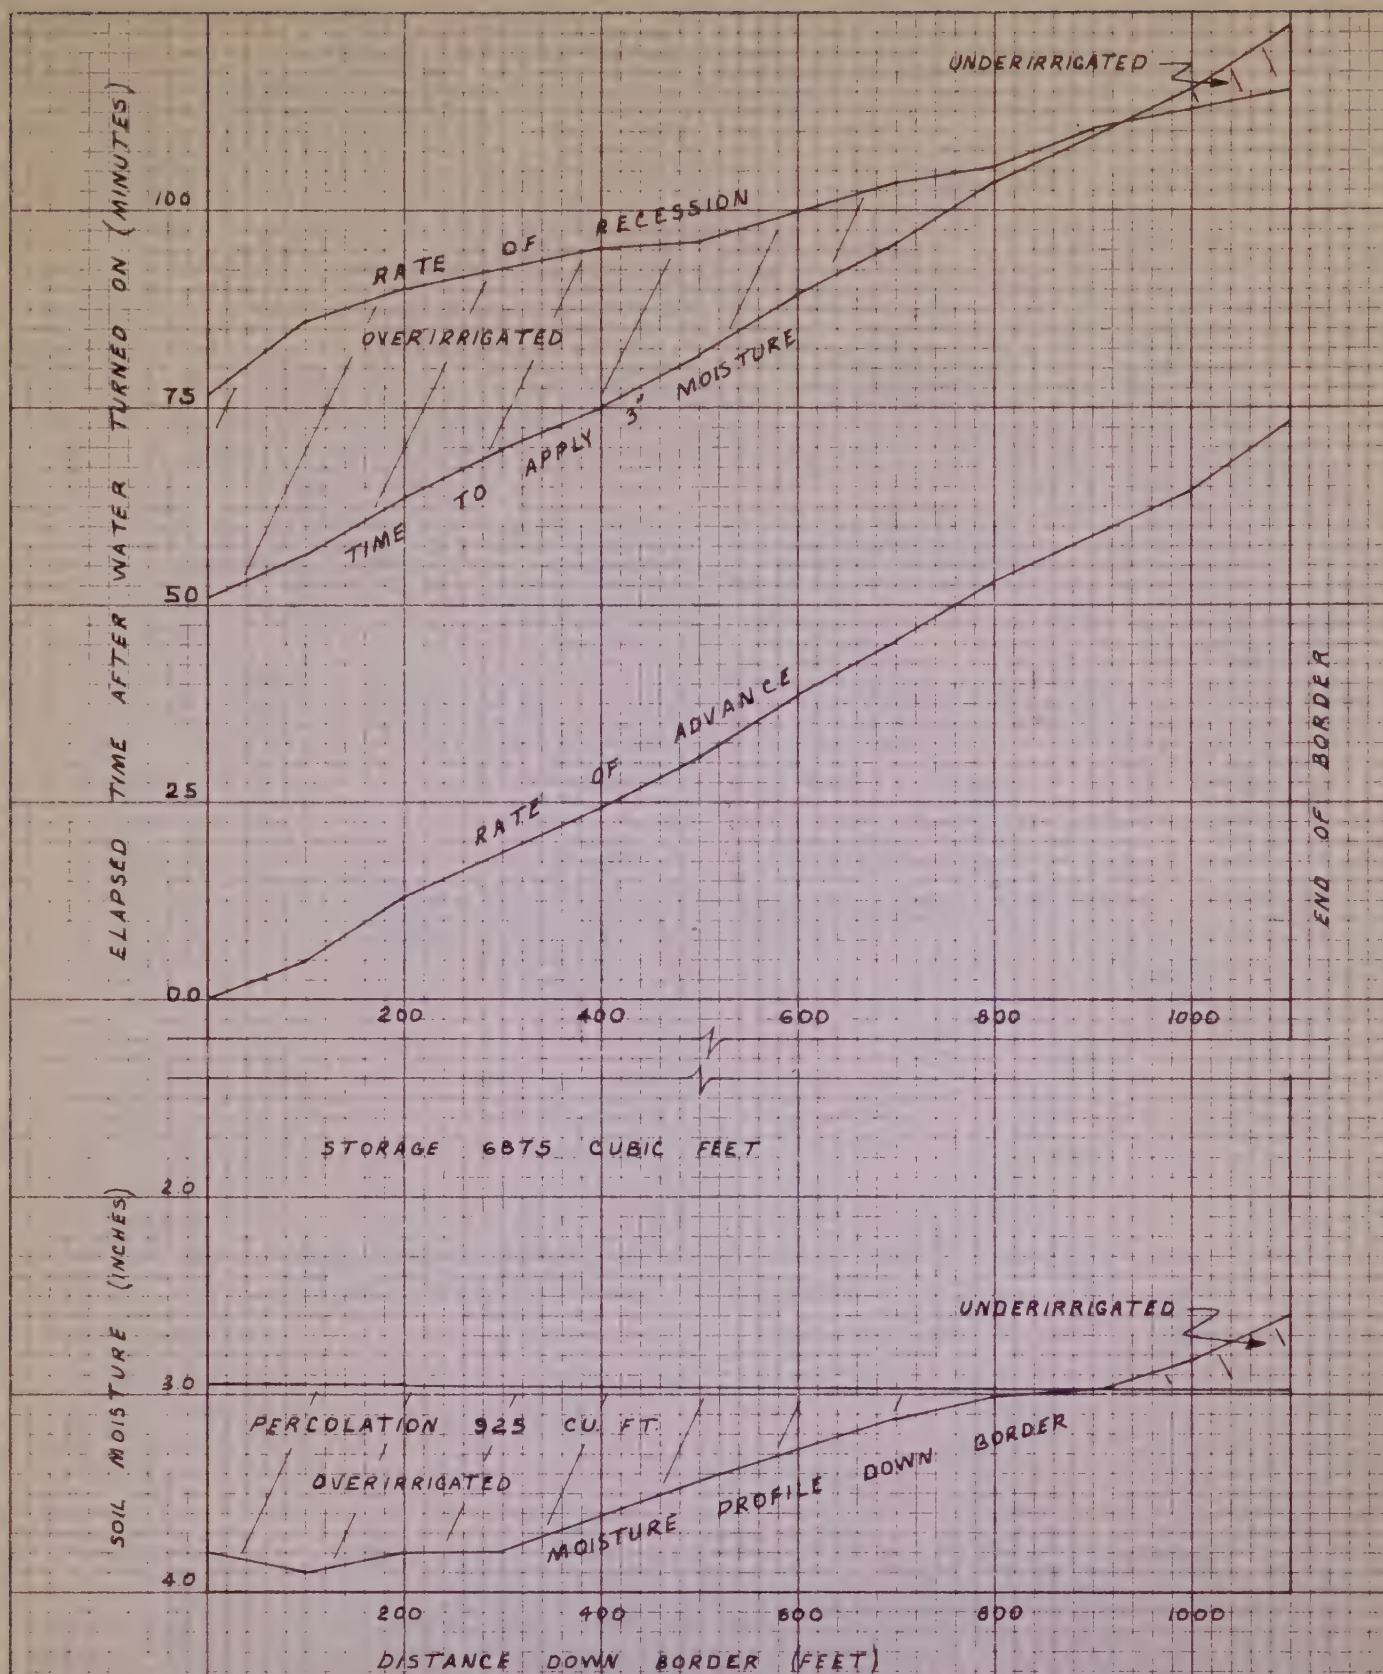
FIGURE 18  
BOW ISLAND PLOTS  
BORDER EVALUATION  
BENCH 8 BORDER 2  
JUNE 11/69

Results of moisture monitoring confirm the fact that the area in general was underirrigated. Although Figure 18 indicates there was overirrigation, neutron meter moisture readings do not indicate any overirrigation as the general moisture increase of the soil profile was 0.75 inches. There is no apparent reason for the indication in Figure 18.

has been included. There are some interesting indications of variations caused by slope changes. Uniform slopes Figures 18a, 18c, 18e, 19a, 19c and 19e show generally even wetting by the irrigations applied in 1969. There were some variations and this appeared more pronounced on the flatter 0.3% slope (Figure 19e).

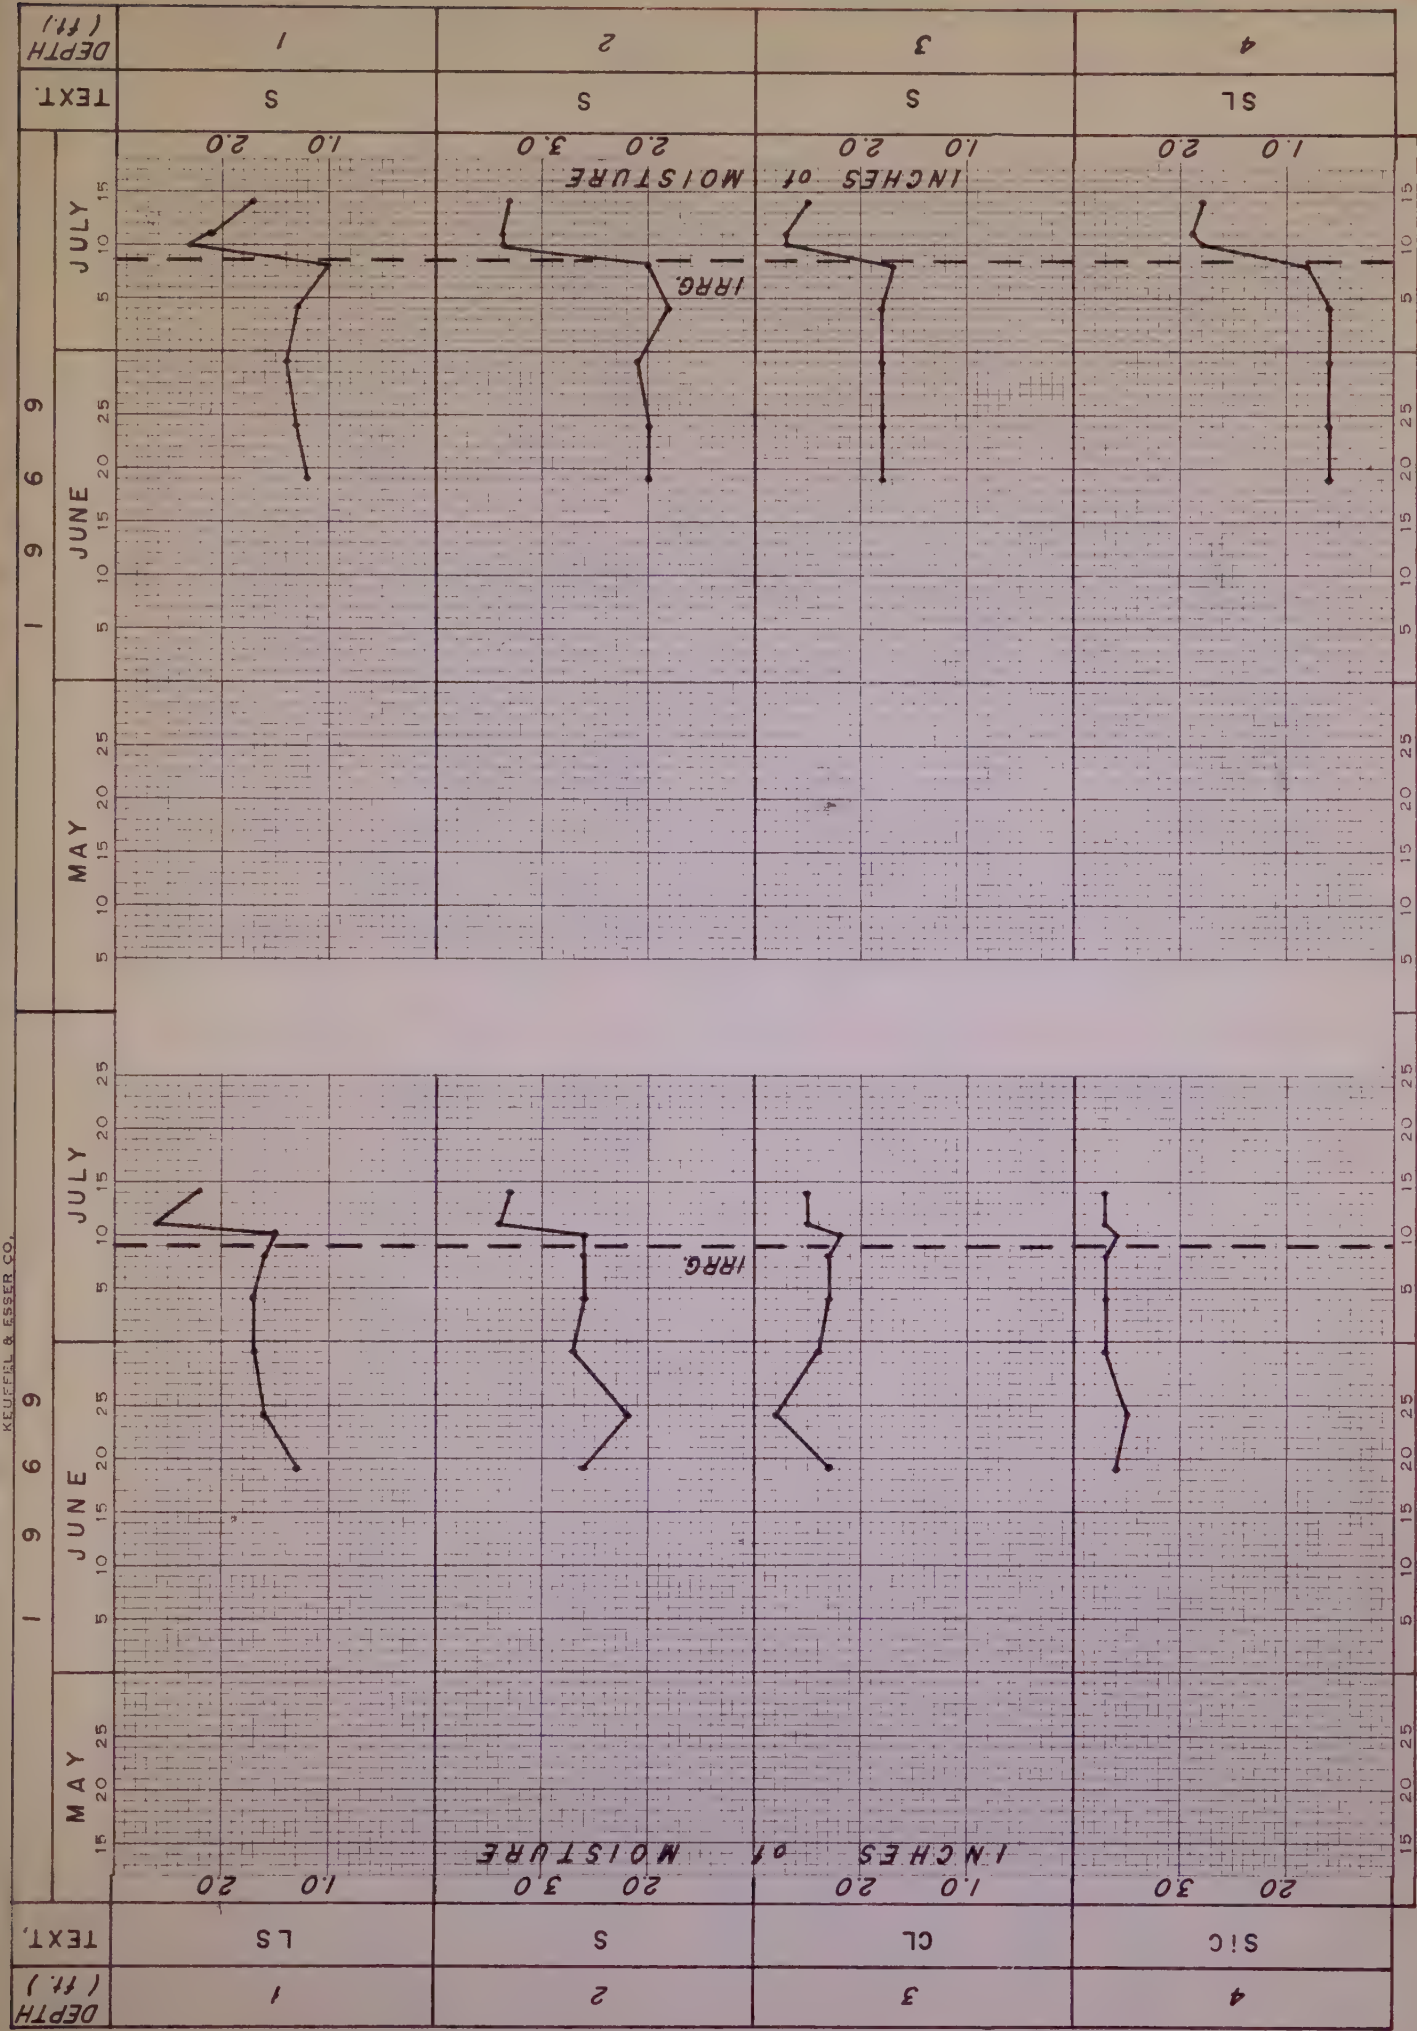
FIGURE: 21

(a) STATION 5 & 50  
 BENCH 5 BORDER 2  
 (b) STATION 8 & 30  
 INSTRUMENTATION: MOISTURE BLOCKS

To illustrate an interesting variation possible as a result of soils Figure 21a was included. The full profile of Figures 21a and 21b had a very pronounced increase in the soil moisture amounts. Figure 21a was not as pronounced as Figure 21b at the 3rd foot of depth. It is interesting to note that in Figure 21a the soils are LS, S, CL whereas in Figure 21b they are S, S, S, SL. This would illustrate the effects of permeability and water holding capacity of soils on water movement and wetting patterns.

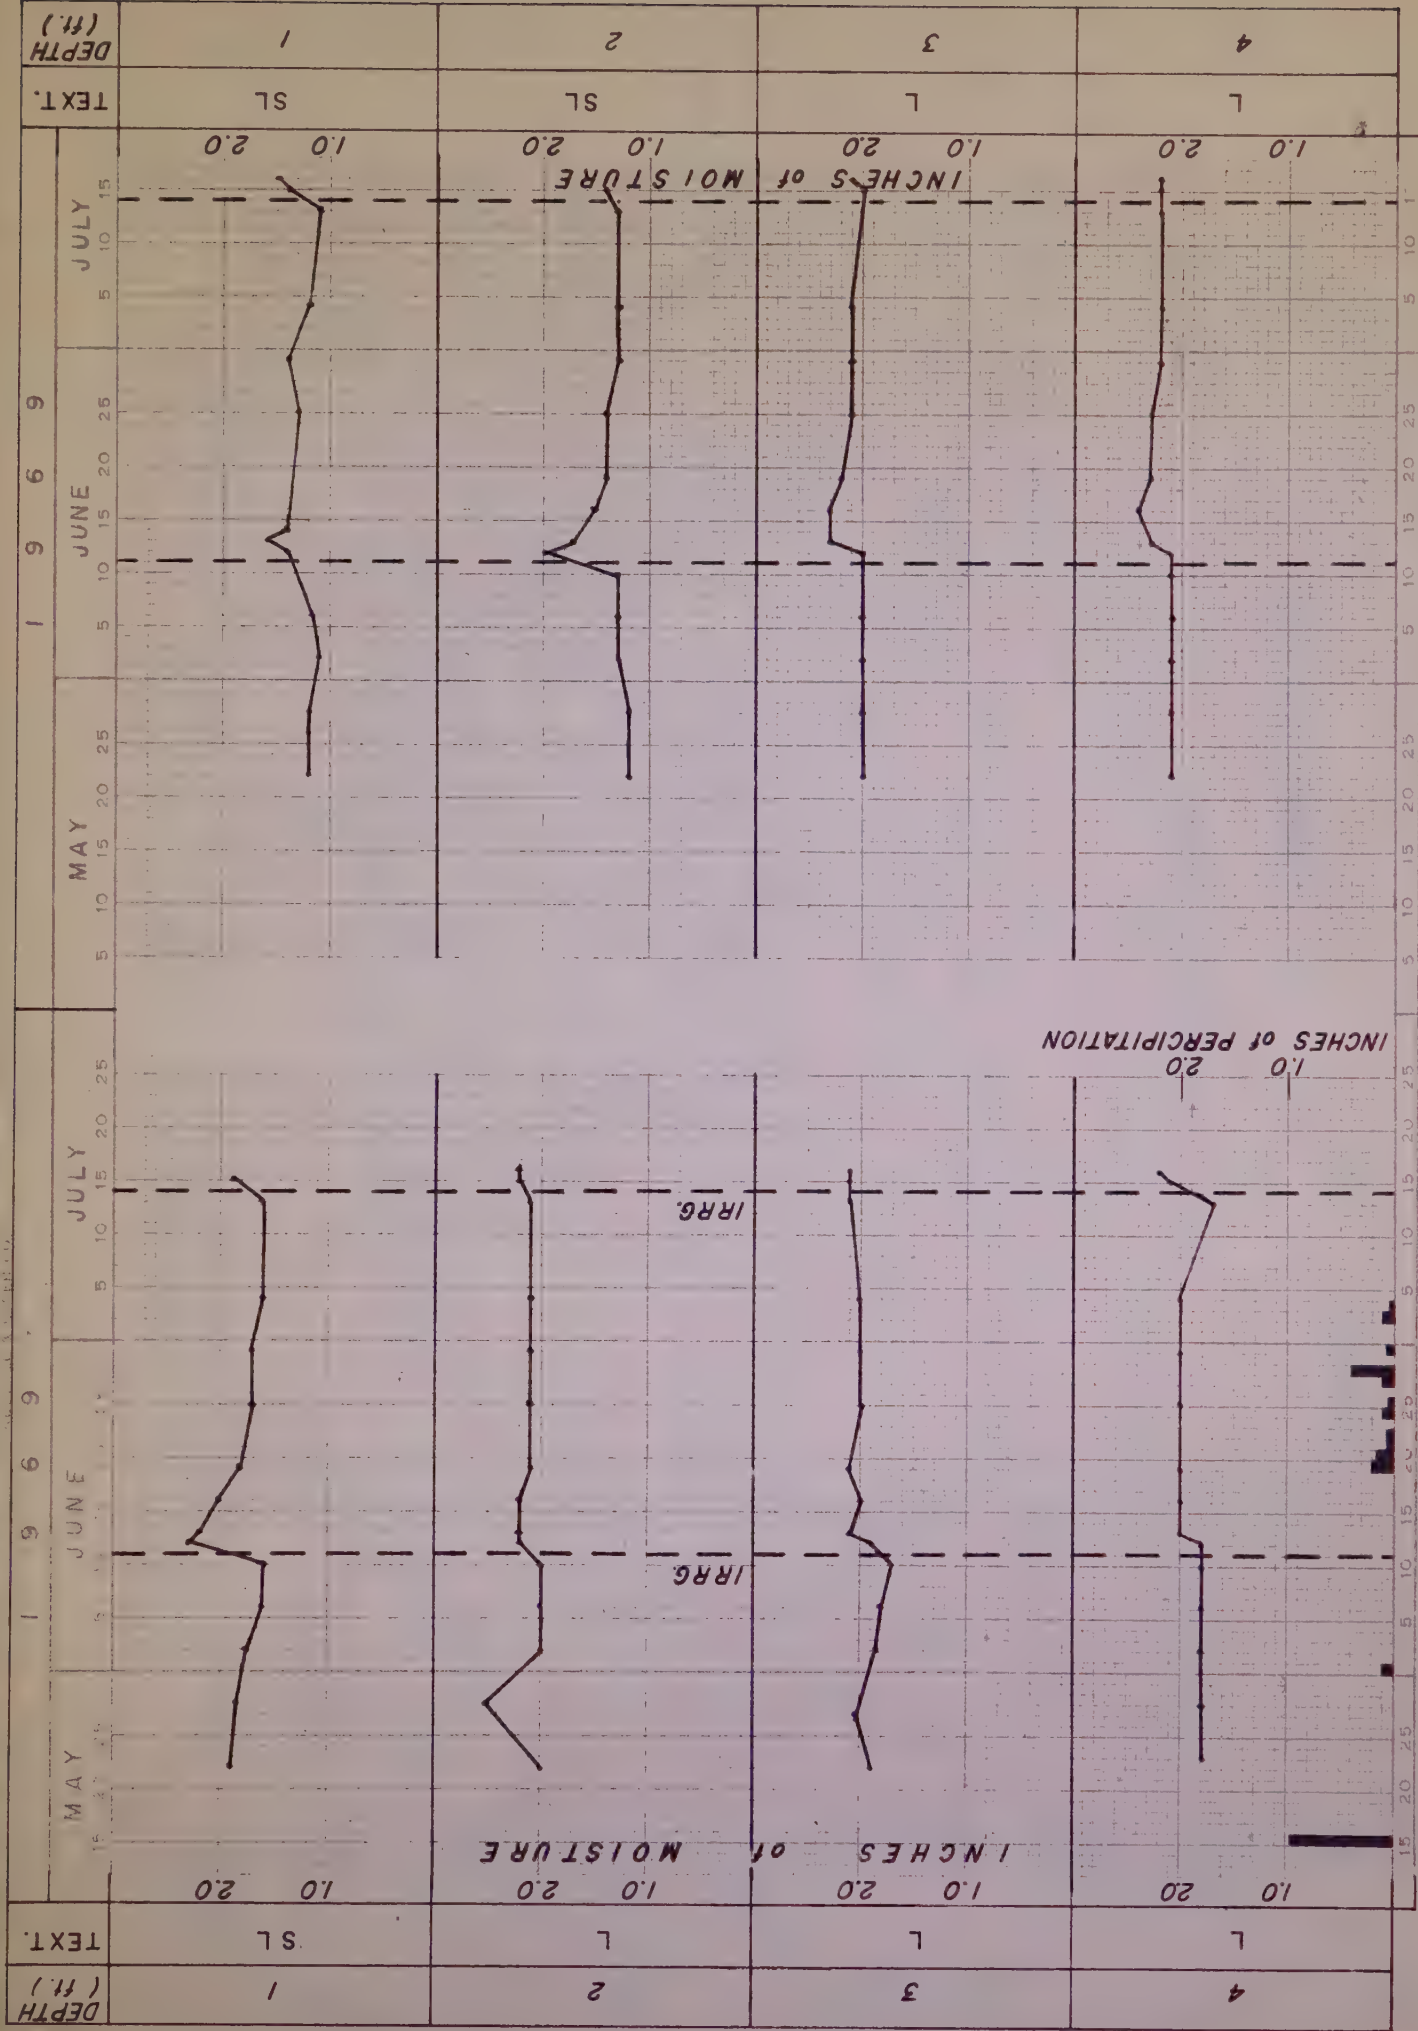
FIGURE 22 (a) STATION 08 50 BENCH 6 BORDER 2 INSTRUMENTATION: TENSIOMETERS (b) STATION 88 30

This plateau effect as noted in previous figures is again evident in Figure 22a. The delay in time of movement to the lower depths is evident. The lack of use by either plants or capillarity is well illustrated by the straight line plots at the 3rd and 4th foot of depth of Figures 22a and 22b. Of interest is the general horizontal nature of the curves at all depths due mainly to the rains in the latter part of June and the first week of July which tended to compensate for consumptive use amounts.
